Product: TV's with Digi Basic chassis

Television No. 1/97

Colour television receivers with Digi Basic chassis, e.g. ST 70-255 IDTV/LOG, M 70-280 IDTV/LOG, SE 7089 IDTV/LOG

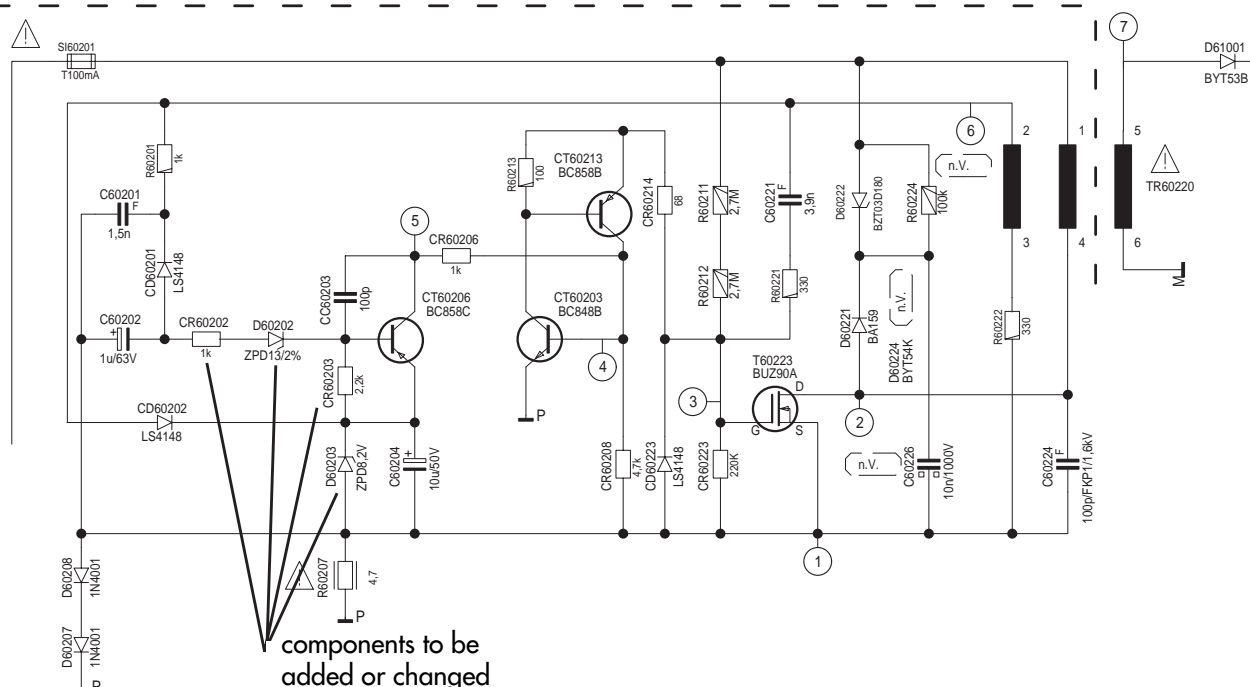
Brown colouration of the circuit board near the diode D 60222 BZT 03D180. Simultaneously the "+Eco" voltage is approx. 5V too high.

Coincidence of unfavourable component tolerances.

Carry out the following changes in the stand-by mains stage:

- Change the Z-diode D 60203 from ZPD 9.1V to 8.2V.
- Change R 60202 from 68 k Ω to 1 k Ω .
- Connect an additional Z-diode ZPD 13 in series with R 60202. Connect the cathode of the diode to the base of the transistor CT 60206.
- Check the rating of the resistor CR 60203 to be 2.2 k Ω .

Check the "+Eco" voltage. Carry out the changes if this voltage is higher than +17 V.

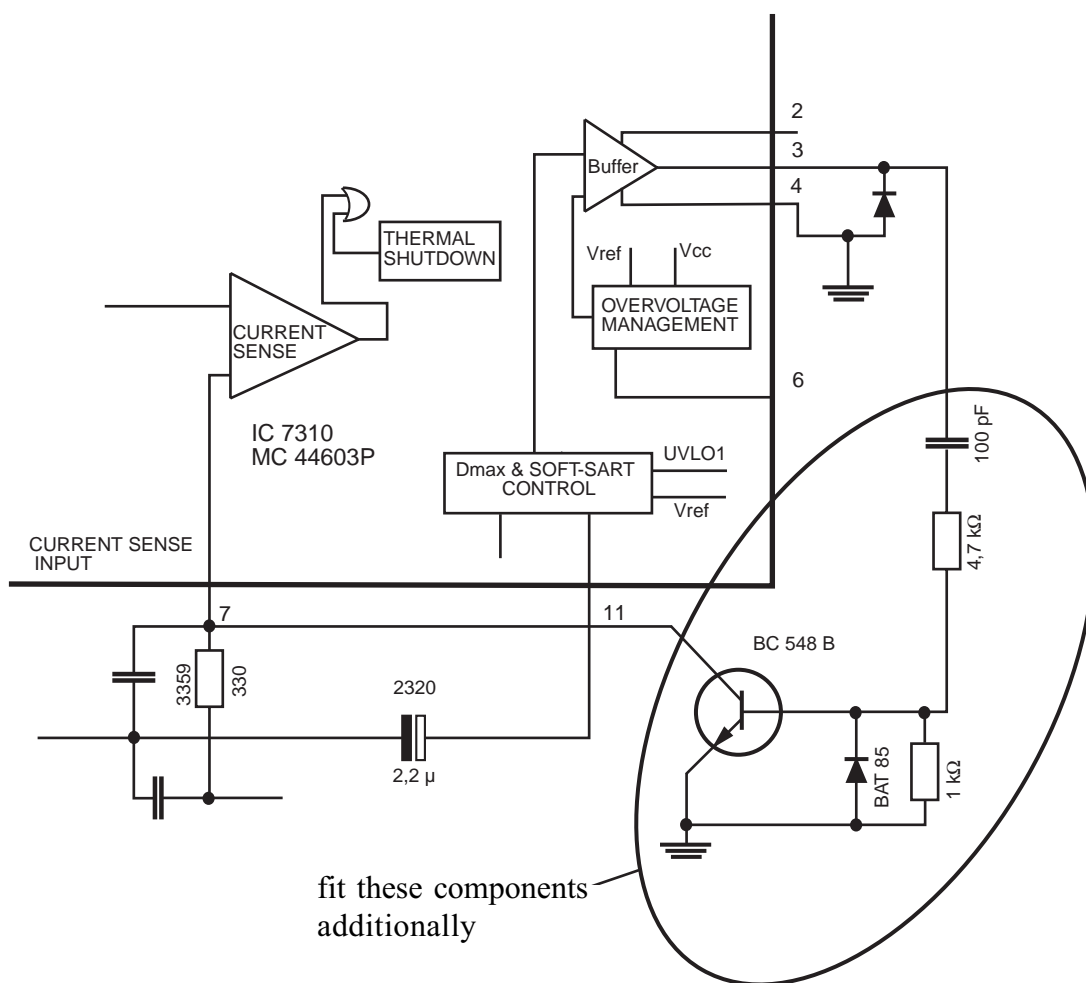
Mains voltage dependent chirp audible in stand-by mode.

Fit an additional transistor stage as shown below into the power supply unit at IC 7310 (MC 44603 P).

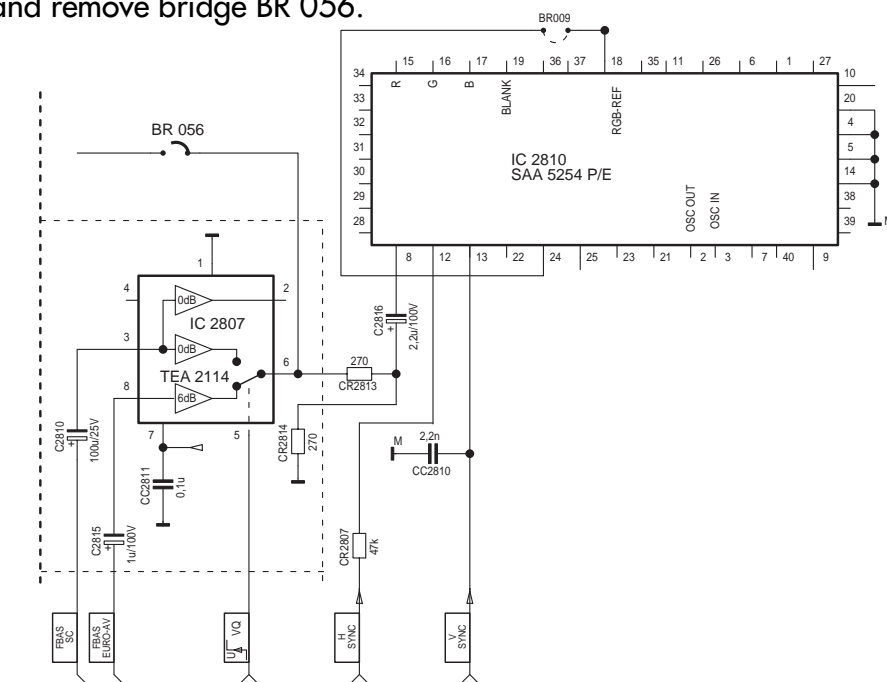
Teletext operation is not possible in "AV" programme position.

The video switch-IC 2807 (TEA 2114) is not fitted in 37 cm television receivers.

Retrofit the following components:

In addition, change the polarity of 2.2 μ F electrolytic capacitor C 2816 (negative terminal to pin 8 of IC 2810) and remove bridge BR 056.

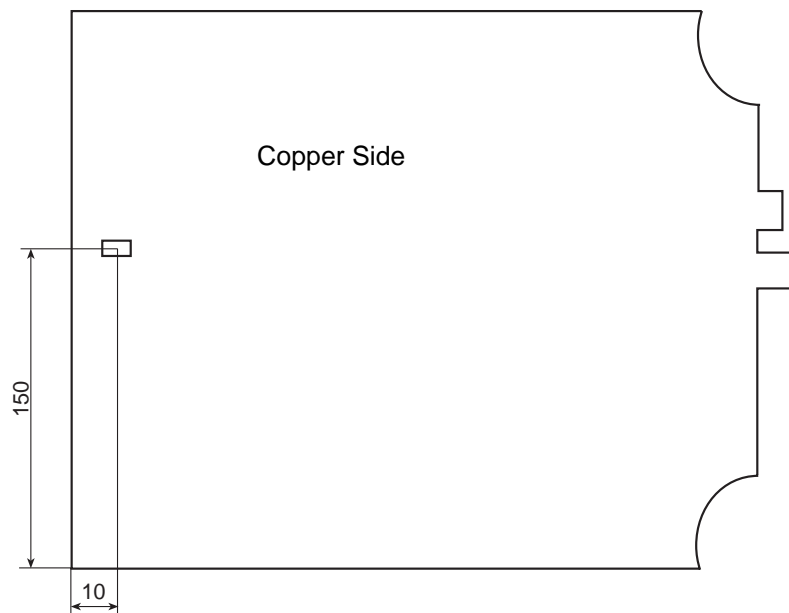
Temperature drift of the +E operating voltage by about 0.2 to 0.3V caused by Z-diode CD 61023. Consequently, IC 34015 TDA 8374 switches off with sudden black/white changes in the picture content or changing scenes.

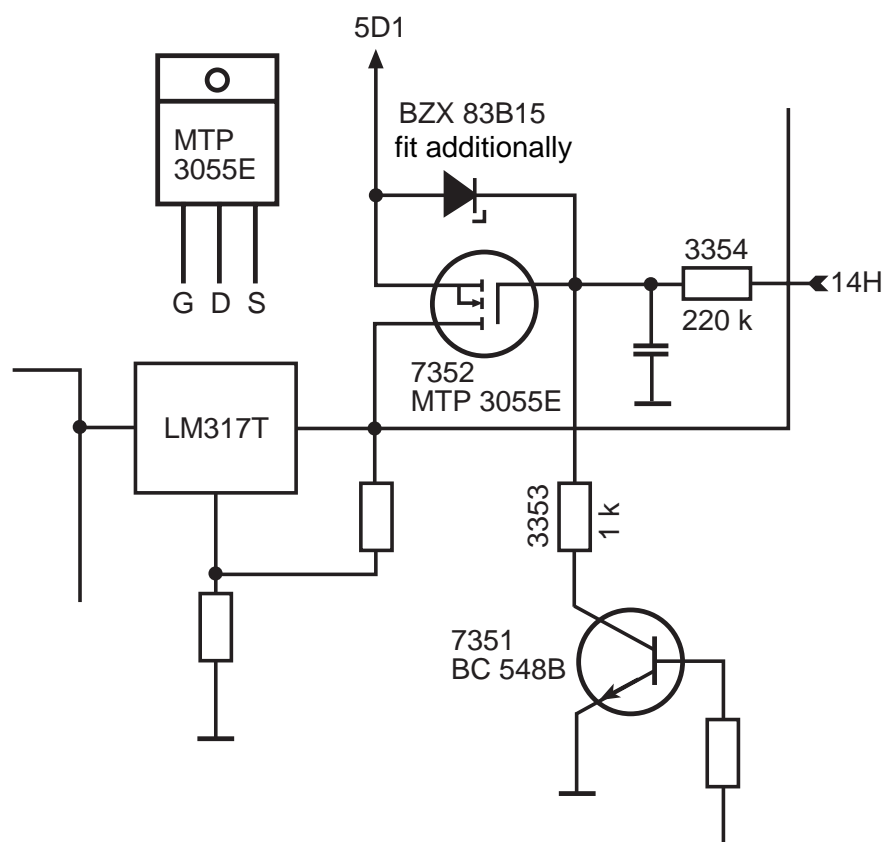
Defect in transistor 7352 (MTP 3055E) caused by static discharges in the TV Recorder.

The Z-diode must strictly be retrofitted if the transistor 7352 fails. This change is carried out already in the factory.

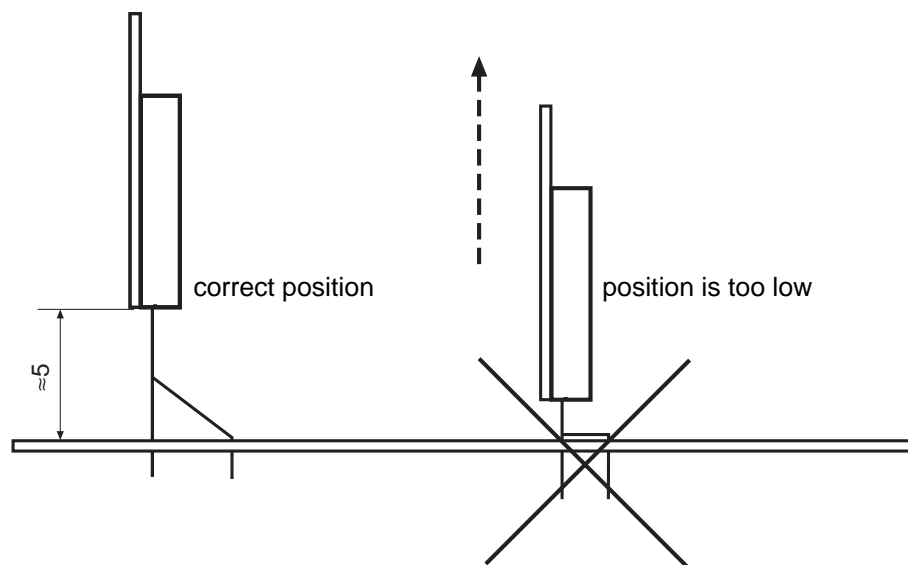
Vertical output stage TDA 4173 fails or thin white lines similar to retrace stripes are visible.

- Should above mentioned symptoms appear do not fail to exchange TDA 4173 AF and solder additionally a 1 nF foil capacitor from pin 1 and from pin 7 each to pin 4 (-K voltage) on the copper side.
- Check the mounting position of the vertical output-IC. If the position of the IC is too low, the pins may temporarily come into contact with the chassis connection on the upper side causing the IC to fail. Additionally, the circuit may already be damaged by the building up force of pressure resulting in a long-term failure. Therefore replace TDA 4173 AF also if it has not been fitted correctly!

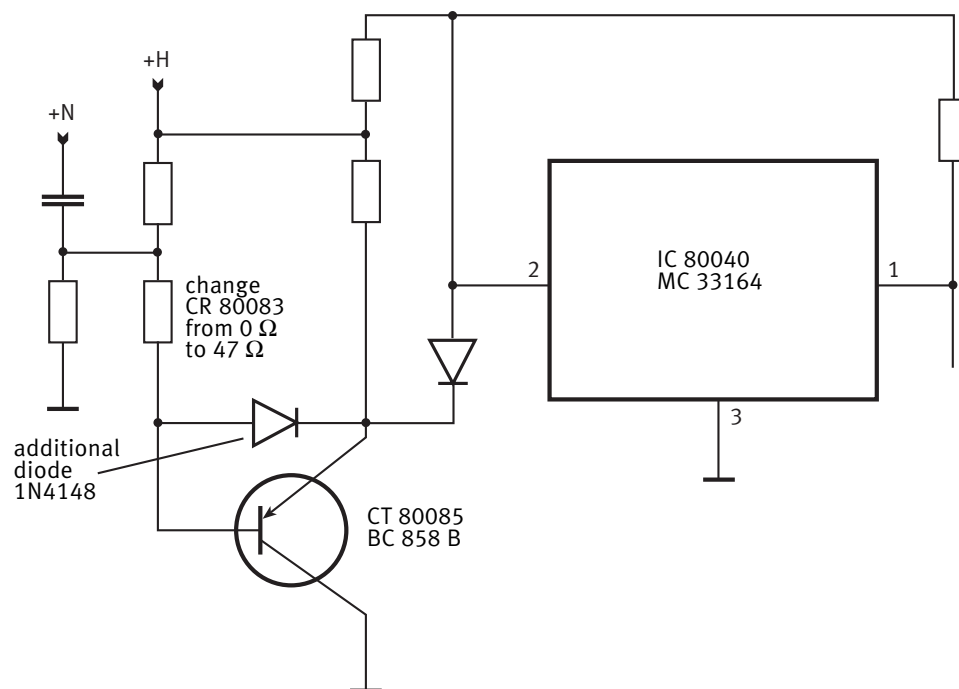
Failure of transistor CT 80085 BC 858B (position X=148, Y=18).

On replacement of the transistor, solder an additional diode 1N4148 from the base to the emitter (anode to base) of CT 80085 and change the resistor CR 80083 from 0 Ω to 47 Ω 5% (structural shape 0805).

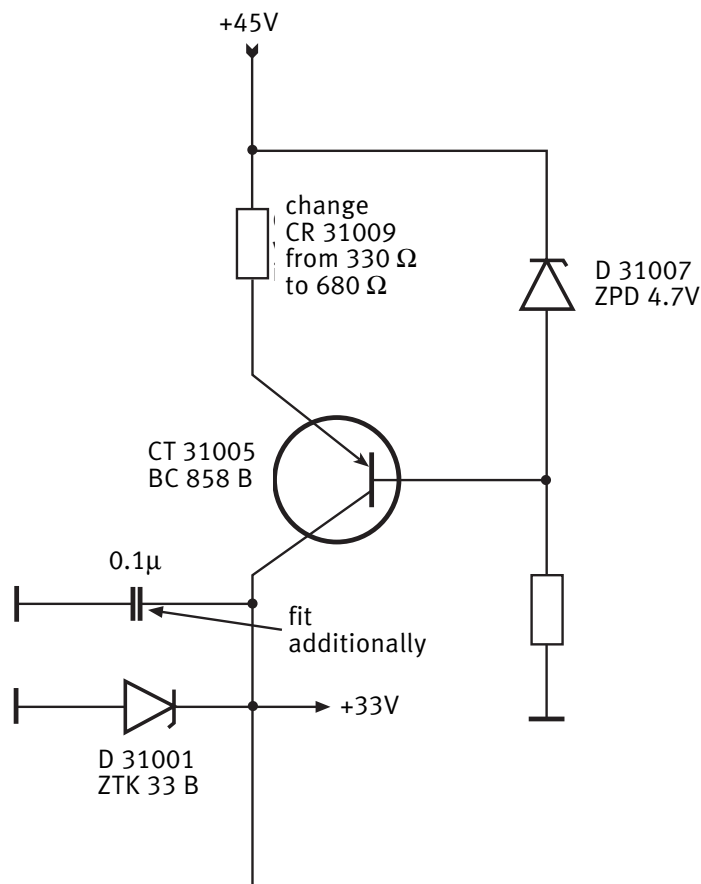
Failure of diode D 31001 ZTK 33B caused by too high a Zener current.

On replacement of the the Z-diode ZTK 33B, change additionally the SMD resistor CR 31009 from 330 Ω to 680 Ω 5% (structural shape 0805) and solder an additional 0.1 μ F foil capacitor in parallel with Z-diode ZTK 33B.

When the Z-diode failed, change the resistor (position X=78, Y=10) and solder an additional capacitor.

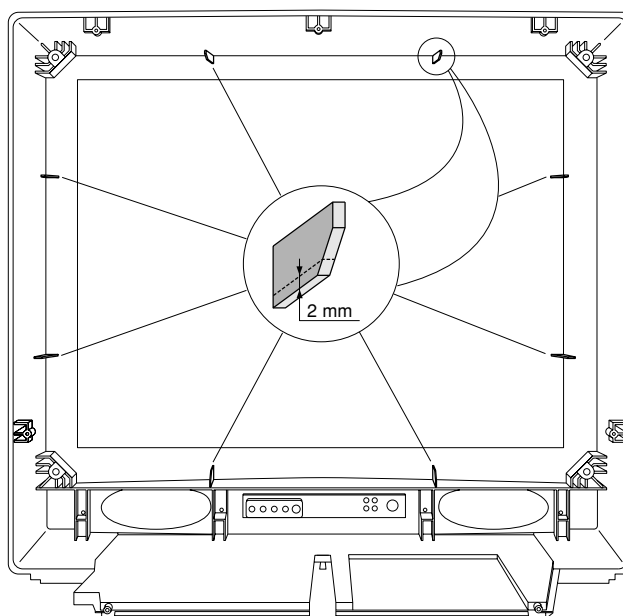
Due to the slightly larger overall dimension, the picture tube touches the fixing ribs within the cabinet. Consequently, when changing the tube, these ribs must be cut by about 2mm (see figure).

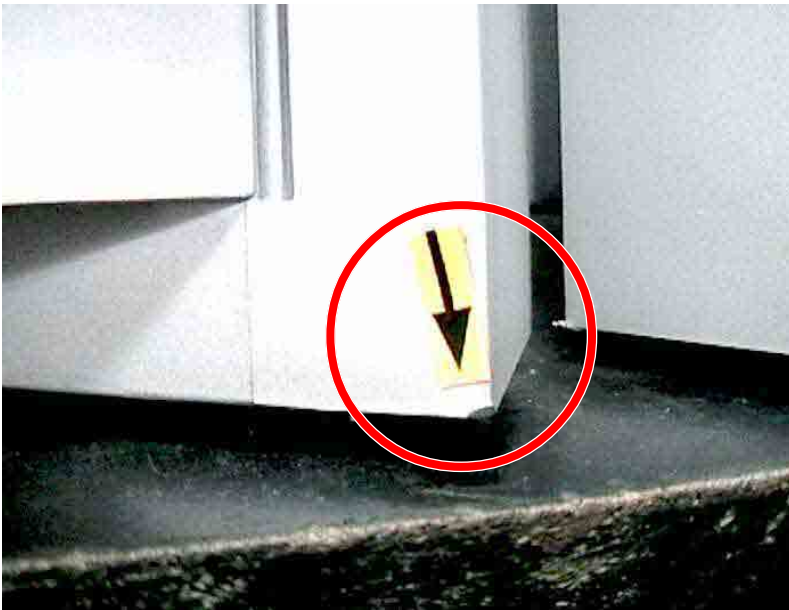
Damage to the bottom corners and edges on the front side.

Due to the small bottom clearance of the front trim, the corners and edges of the trim can be damaged when putting down the TV set in an inexperienced way.

When transporting the TV set make absolutely sure to put it always down in horizontal position and not to tilt it to the front to prevent the vulnerable corners and edges from being dented.

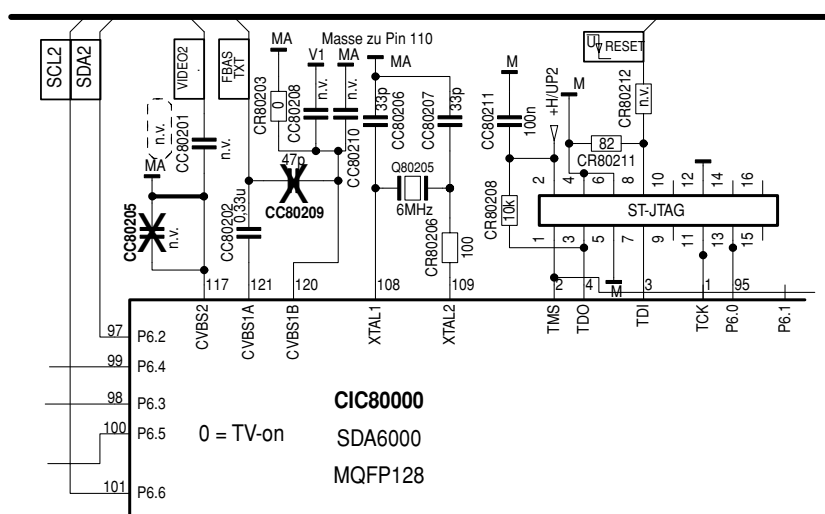
This failure may be caused by an uncontrolled oscillation of the CVBS input and a faulty software library of the processor.

For the positions of the components concerned on the Feature module please see the circuit diagram excerpt and the PCB illustrations on page 2.

- Remove the chip capacitor CC80209 (coordinates x71/y78) if provided.
- Connect CIC80000, Pin 117 with ground (e.g. chip capacitor CC80205 (coordinates x71/y81), replace with a chip jumper, or solder in a wire bridge from Pin 117 to ground).

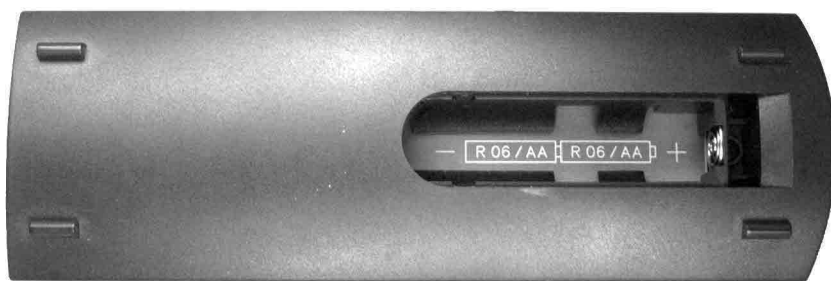
Missing hints to battery polarity in battery compartment.

Insert the batteries as shown in the figure below.
