#	DETAIL OF CHANGE(S)		REASON FOR CHANGES
1	Change of a Power Transformer in Power Supply Assy	1	To prevent flicker of picture

SERVICE INFORMATION

Date: Oct.13,2000 **No.:** SI-D01008 (1/2)
MODEL No. * **SER.No.** **S/M No.** **PG**

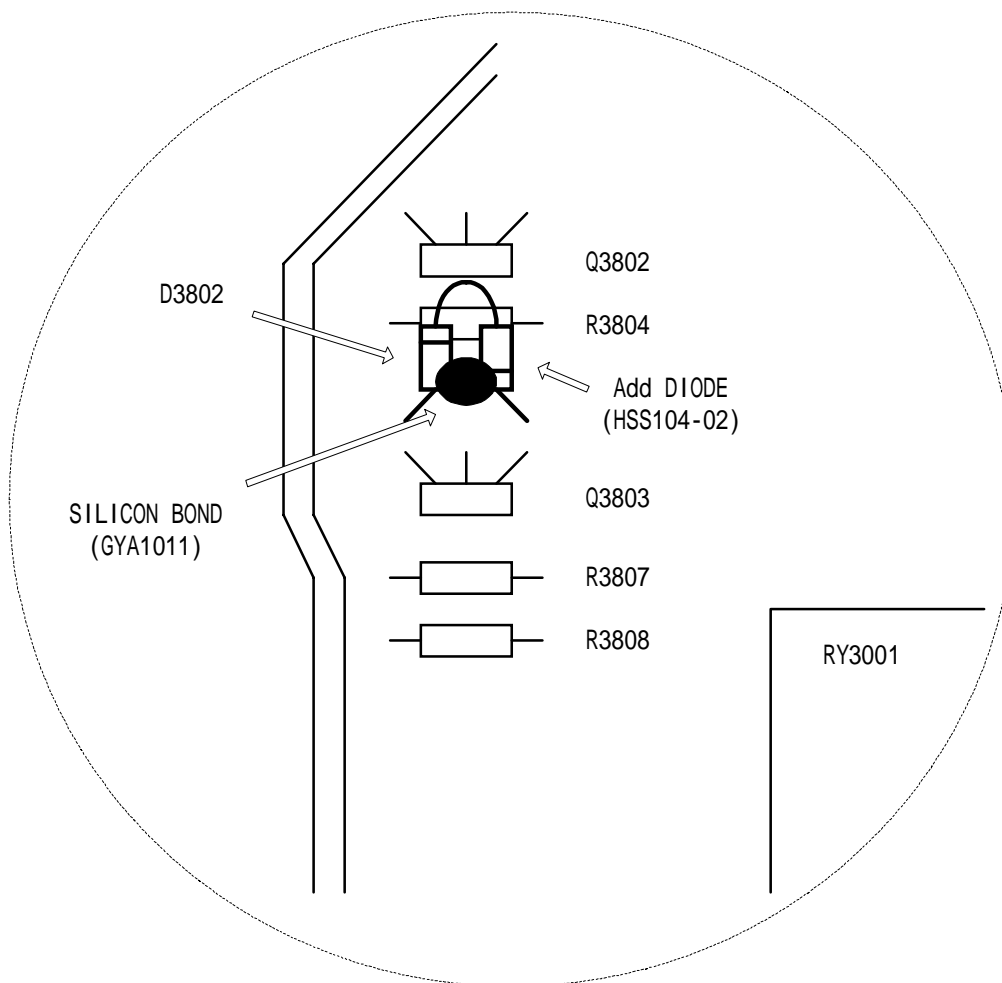
MAIN POWER ASSY (AWR1077) PART'S VIEW

CAUSE
In Main Power Assy (ARW1077), noises enter into the Power ON/OFF signal coming from Microcomputer, and it causes malfunction.

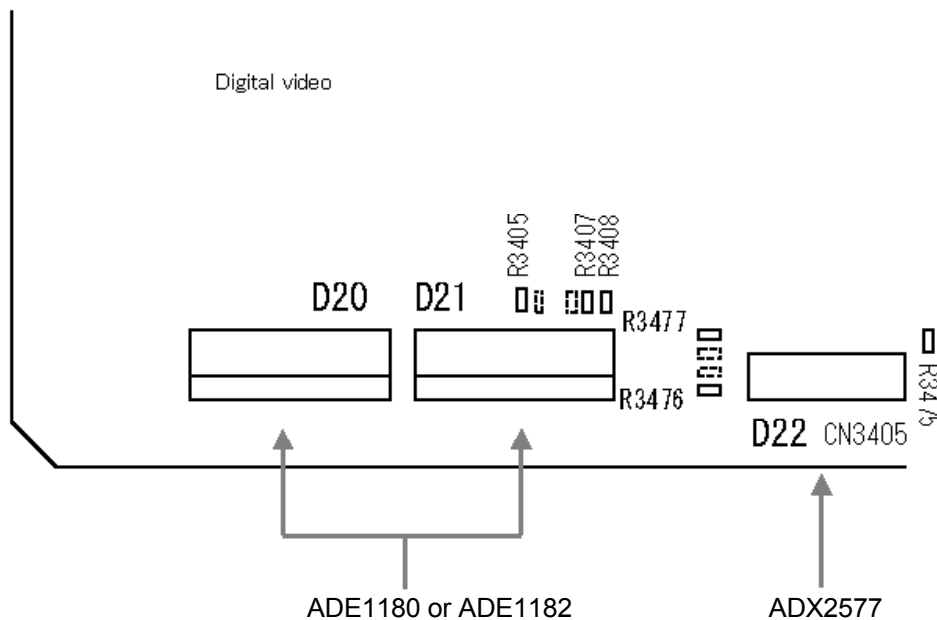
R3405,3407,3408,3475,3476,3477 are same all resistor(10 ohms)

/ position of R3475,3476,3477 and R3405,3407,3408 (fig,1)

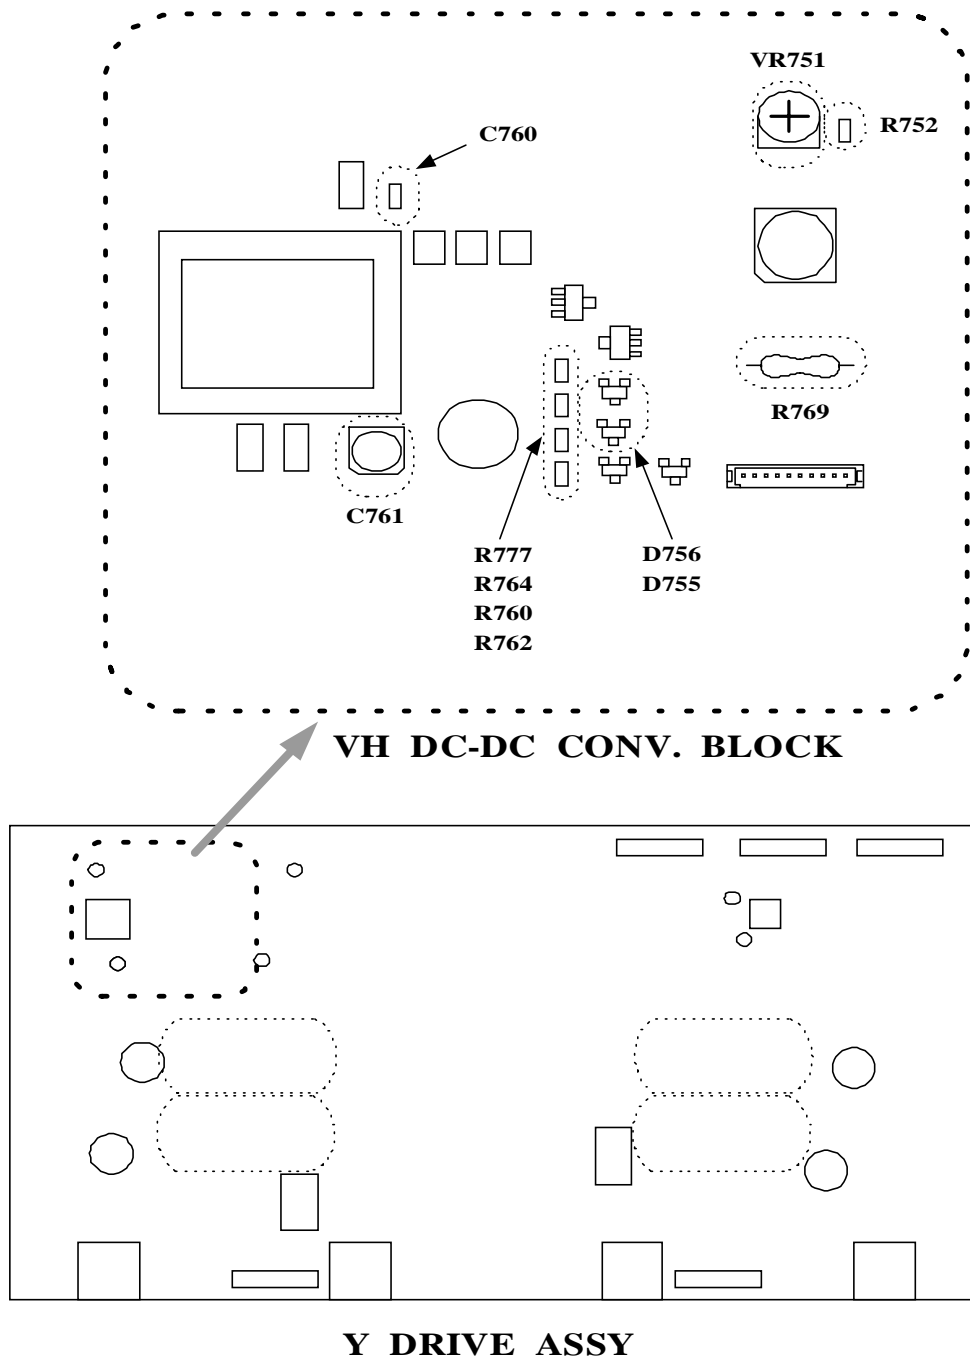
Parts location

- 1) Prepare a Service Parts Kit, **GXX1211**, consists of the following new parts
- 2) Replace old parts with new parts

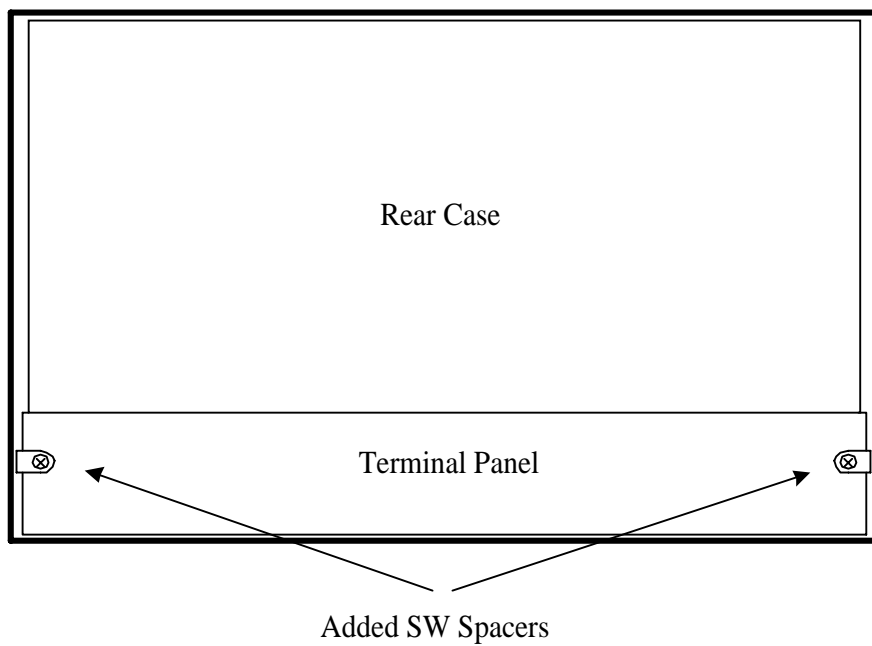
Adeed place of SW Spacers

SW Spacer

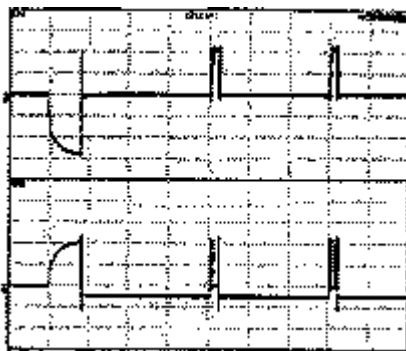
Sustain Waveforms

*** Sustain Waveform (1 sub-field)**
 ch 1 : K3107(X.PSUS) - K3201(SUSGND)
 V: 100V/div. H: 500microsec/div.
 ch 2 : K2220(Y.PSUS) - K2219(SUSGND)
 V: 100V/div. H: 500microsec/div.

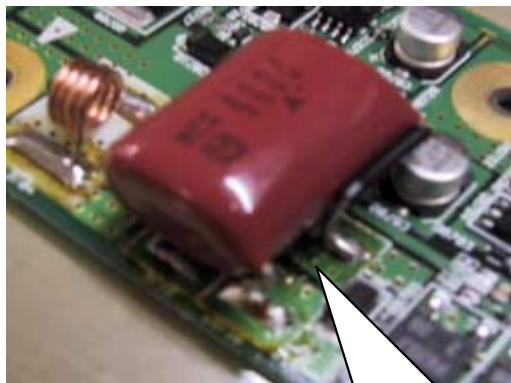
Prevent electrical contact using an insulated tube.

CAUSE 1 Short circuit of Capacitors (C6716 or C6718) in the address resonance ASSY.

1-b "When you repair the PDP on site"

Replace both upper and lower Address Resonance Assy with new Assy

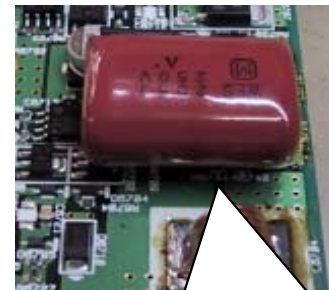
Solder the capacitor on the lands of C6716.

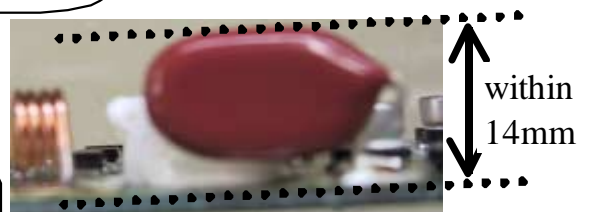
Put white silicon bonding between the capacitor and board.

Confirm printed number
WFS 205J
250V

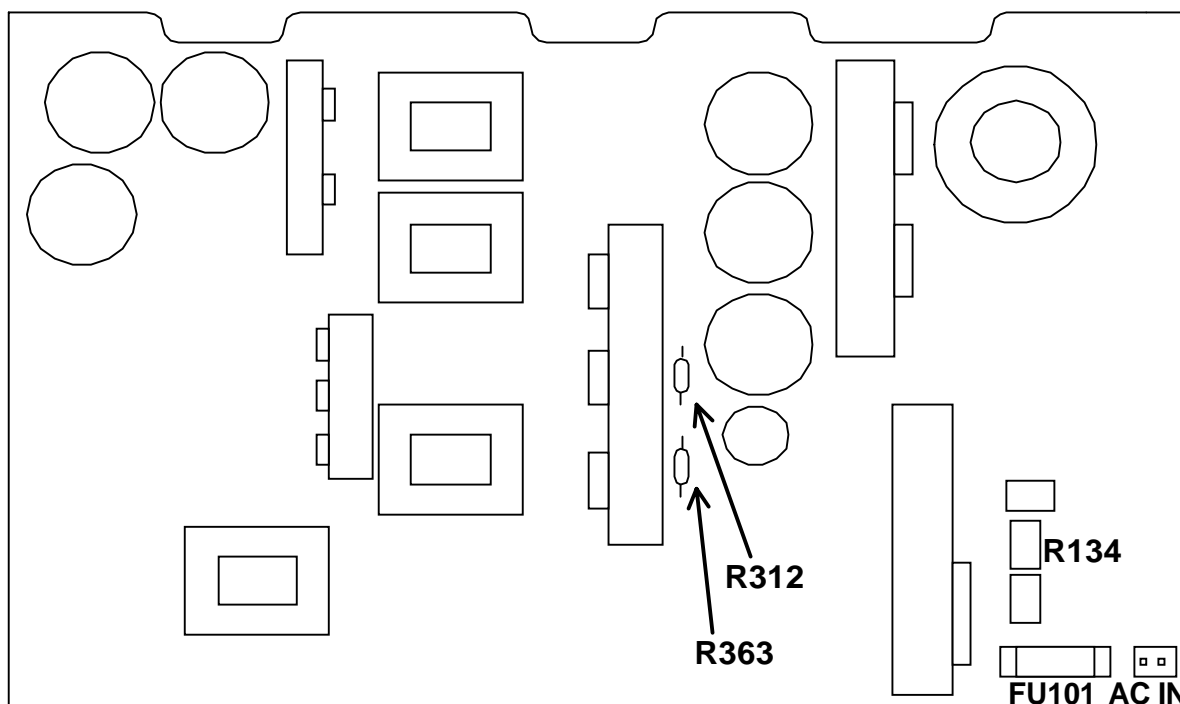
PDP-502 series
Replacement parts location of POWER SUPPLY ASS'Y
(Ref. A: AWZ6405, Ref. B: AWZ6506)

R363, R312	Current part No : RS1LMFR22J
	New part No : ACN1157

R134	Current part No : ACN1139
	New part No : ACN1160

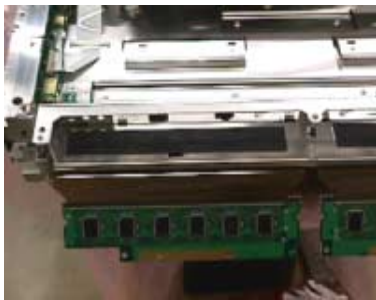
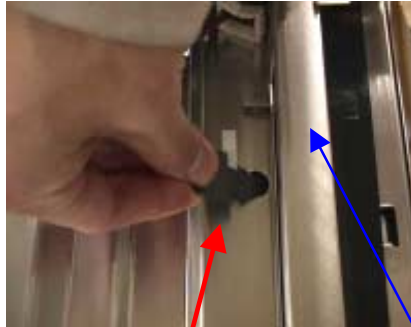
1. Disassemble rear case.
2. Disassemble Y Drive assy.
(Please refer page 87 of S/M ARP3111)
3. Insert antivibration spacer into the following hole on panel chassis assy.
(However you can insert the spacers there by only disassembling Y DRIVE assy)

If it is hard to insert a spacer,
Please lift up this chassis a little
and then insert the spacers.

SERVICE REMEDY

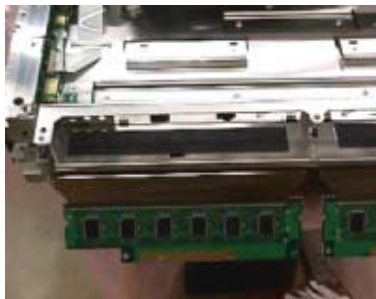
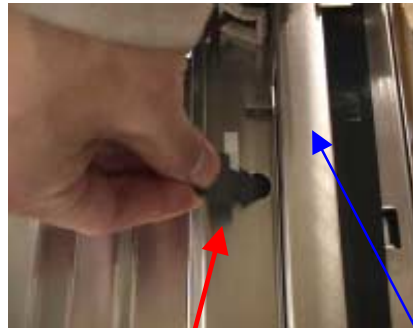
1. Disassemble rear case.
2. Disassemble Y Drive assy.
(Please refer page 87 of S/M ARP3111)
3. Insert antivibration spacer into the following hole on panel chassis assy.
(However you can insert the spacers there by only disassembling Y DRIVE assy)

If it is hard to insert a spacer,
Please lift up this chassis a little
and then insert the spacers.

**SERVICE REMEDY**

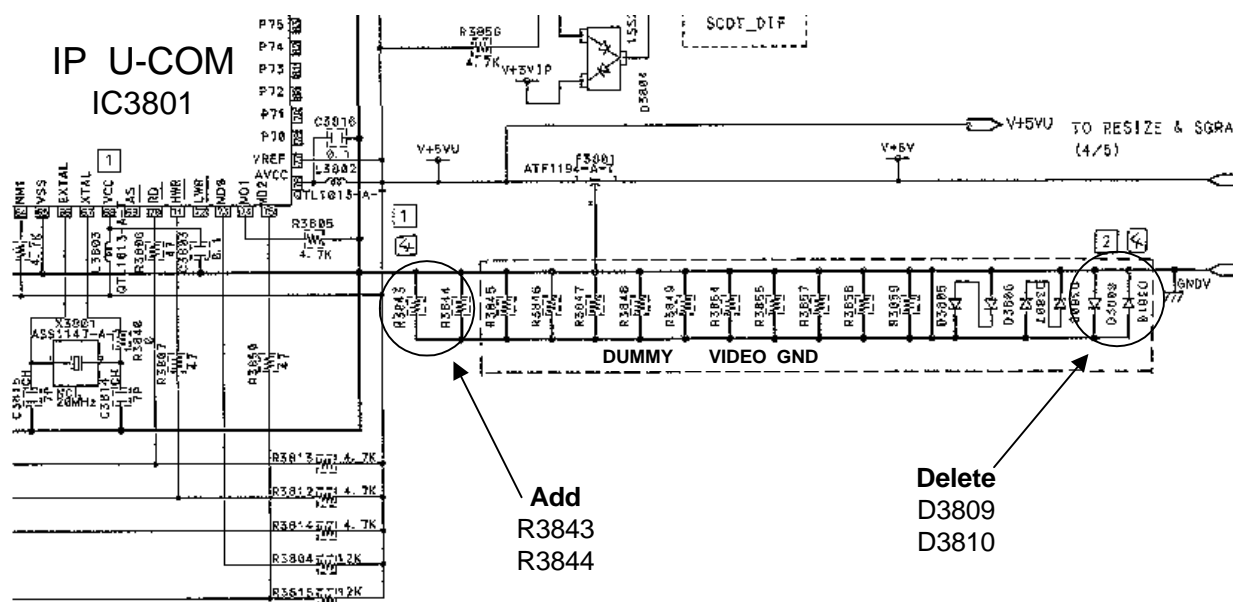
REASON 1 To prevent mis-operation when electricity is discharged.

Ref		CURRENT	PARTS	CO	NEW	PARTS
*	#	SYMBOL/DESCRIPTION	PART NUMBER	DE	PART NUMBER	SYMBOL/DESCRIPTION
A	1	D3809	1SS352-TRB		Deleted	
A	1	D3810	1SS352-TRB		Deleted	
A	1		Added		R3843	RS1/16SOROJ
A	1		Added		R3844	RS1/16SOROJ

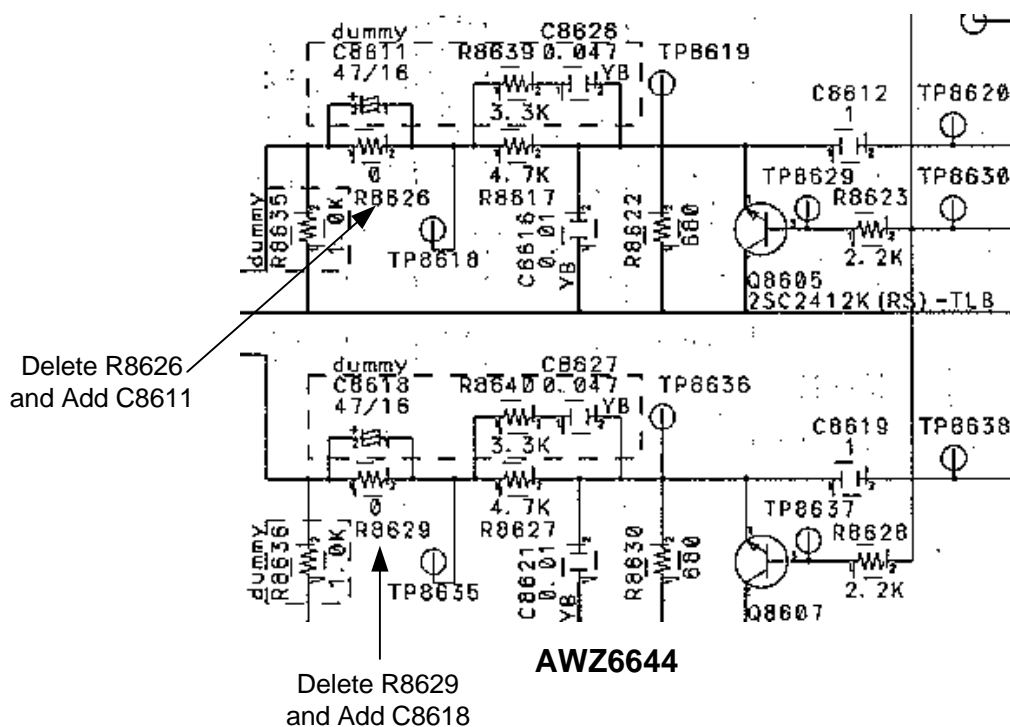
REASON	1	Remedy for not emitting the pop sound when the input is switched or when the power supply is turned on and off.
--------	---	---

Ref		CURRENT	PARTS	CO	NEW	PARTS
*	#	SYMBOL/DESCRIPTION	PART NUMBER	DE	PART NUMBER	SYMBOL/DESCRIPTION
A	1		Added		CEAT4R7M50	C8611
A	1		Added		CEAT4R7M50	C8618
A	1	R8626	RS1/16S0R0J	Deleted		
A	1	R8629	RS1/16S0R0J	Deleted

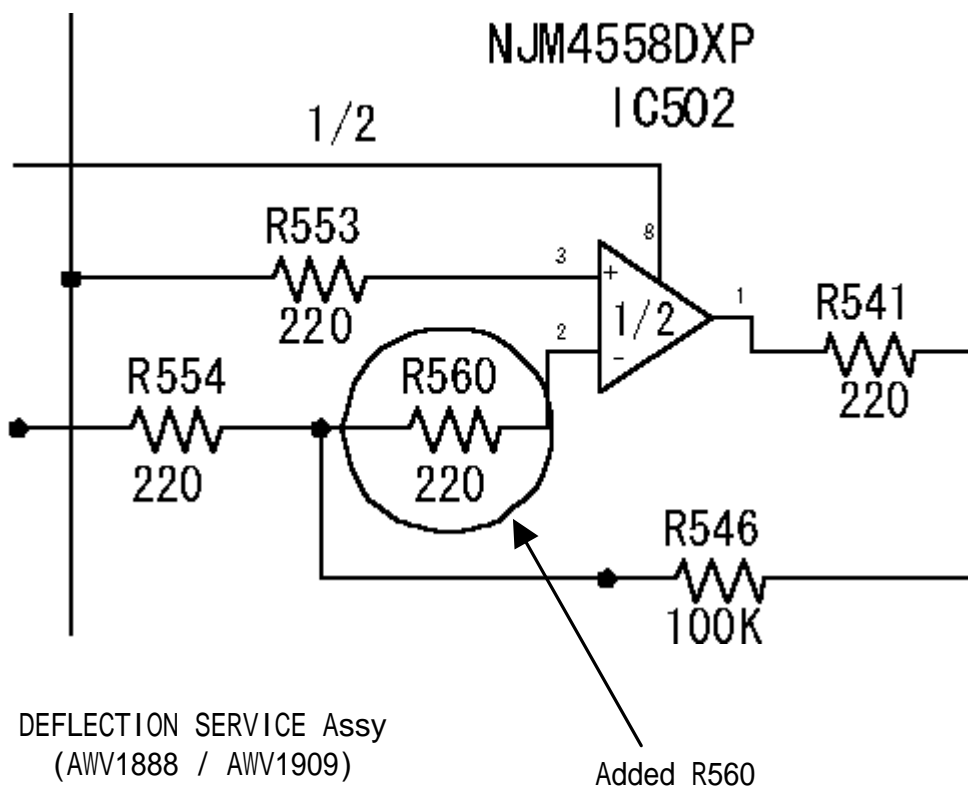
REASON 1 To prevent IC502 being destroyed when electricity is discharged.

Ref		CURRENT	PARTS	CO	NEW	PARTS
*	#	SYMBOL/DESCRIPTION	PART NUMBER	DE	PART NUMBER	SYMBOL/DESCRIPTION
A	1		Added	-	RD1/4PU221J	R560

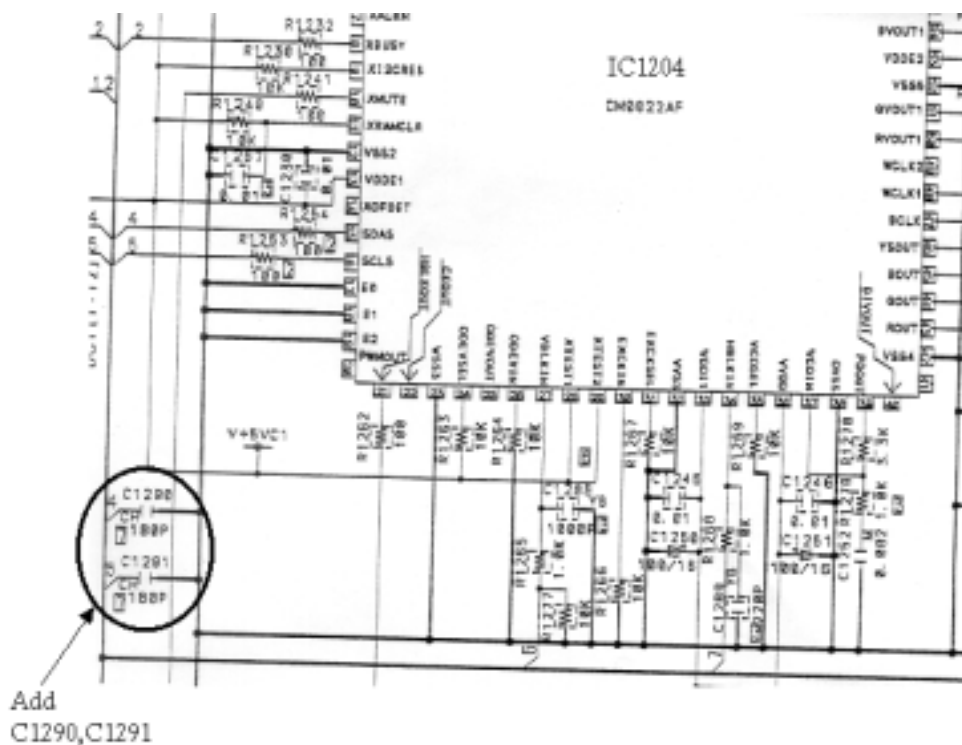
REASON 1 Countermeasure for broken convergence data problem.

Ref		CURRENT	PARTS	CO	NEW	PARTS
*	#	SYMBOL/DESCRIPTION	PART NUMBER	DE	PART NUMBER	SYMBOL/DESCRIPTION
A	1		Added	-	CCCCH181J50	C1290
A	1		Added	-	CCCCH181J50	C1291
