Product: TV's with Digi Basic chassis

Television No. 1/97

Colour television receivers with Digi Basic chassis, e.g. ST 70-255 IDTV/LOG, M 70-280 IDTV/LOG, SE 7089 IDTV/LOG

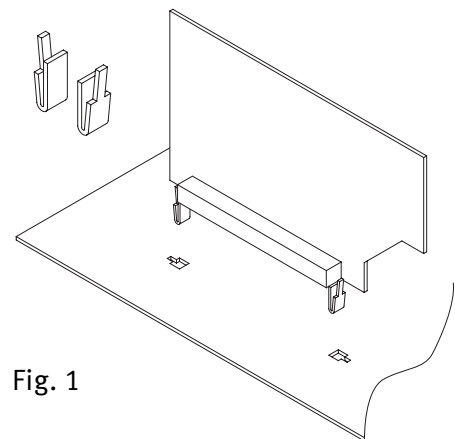
Fig. 1

1. The traditional black socket terminal strips of the modules are additionally provided with locking lugs which, in addition to a module holder, prevent the module from slipping out. The module can be dismantled from above or below by pressing the locking lugs together.

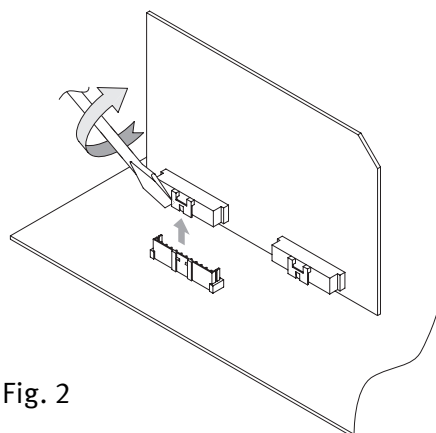
Fig. 2

2. The modules of the colour television receivers with chassis CUC 20xx are fitted with a new plug-in system. They can be dismantled by disengaging the locking lug with a screw driver. In future, it will also be possible to release the lugs from below through additional drilled holes in the chassis.

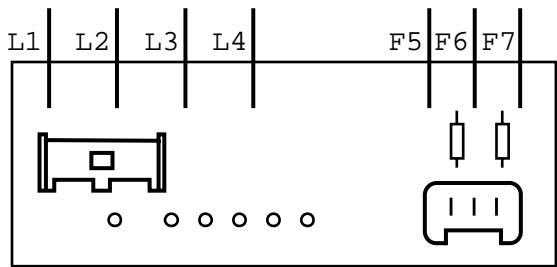
The picture tubes A 68 ESF 002X43 (without coating) and A 68 ESF 202X43 (with coating) fitted into television receivers with above mentioned chassis are no longer available. These picture tubes are not fully compatible with the replacement tubes A 68 ESF 002X143 / A 68 ESF 202X143.

- changed yoke connections:
The figure below shows the connections of the deflection unit for the new picture tubes A 68 ESF 002X143 part no. 8300 068 24300 and A 68 ESF 202X143 part no. 8300 068 20400.

- L1 - red yoke connecting lead (horizontal)
- L2 - black yoke connecting lead (horizontal)
- F5 - green yoke connecting lead (vertical)
- F7 - white yoke connecting lead (vertical)

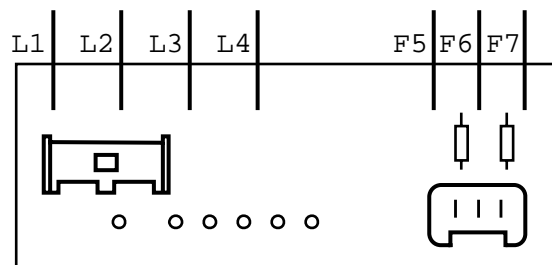
The picture tubes A 68 ESF 002X11, A 68 ESF 002X011 (without coating) and A 68 ESF 202X11, A 68 ESF 202X011 (with coating) fitted into television receivers with above mentioned chassis are no longer available. These picture tubes are not fully compatible with the replacement tubes A 68 ESF 002X111 / A 68 ESF 202X111.

The figure below shows the connections of the deflection unit for the new picture tubes A 68 ESF 002X111 and A 68 ESF 202X111.

L1 - red yoke connecting lead (horizontal)
 L2 - black yoke connecting lead (horizontal)
 F5 - green yoke connecting lead (vertical)
 F7 - white yoke connecting lead (vertical)
